1. AGENCY USE ONLY (Leave blank)	2. REPORT DATE 1996	3. REPORT TYPE AND DATES COVERED Final Report		
4. TITLE AND SUBTITLE The Old Hospital Complex (5EP1778) Fort Carson, Colorado		5. FUNDING NUMBERS

13. ABSTRACT (Maximum 200 words) <p>The Old Hospital Complex (5EP1778) at Fort Carson, Colorado, consists of 59 buildings. The Complex was built during World War II and is significant due to its association with the history of the United States. The complex is semi-permanent construction, constructed from the Department of the Army's Series 800 plans. This report documents the complex in accordance with Section 1(g) of the Memorandum of Agreement enacted among the Department of the Army, Headquarters Fort Carson, the Colorado State Historic Preservation Office, and the Advisory Council on Historic Preservation.</p> <p style="text-align: center;">DTIC QUALITY INSPECTED 2</p>

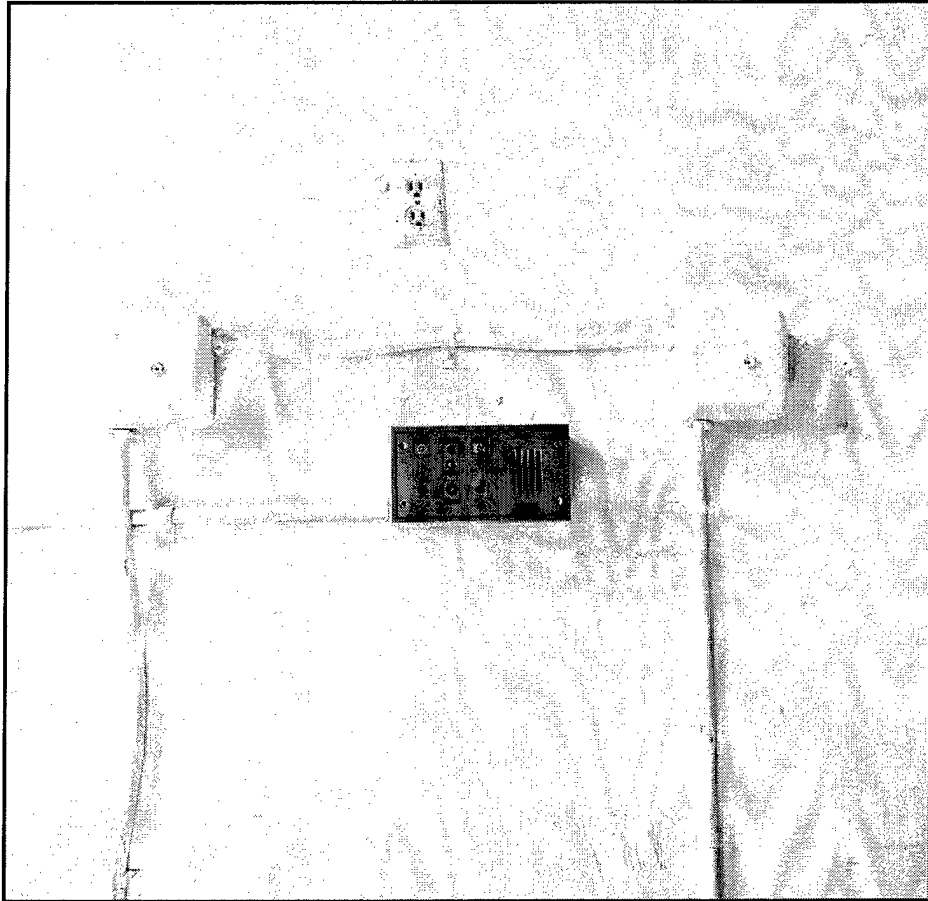
Figure V.68 5EP1778. Building S6230, Combination Ward, 800 Series, Type HCW-88. Detail from interior of second floor. Shows patient call panel, on south wall. Roll 1G, Exposure 4.

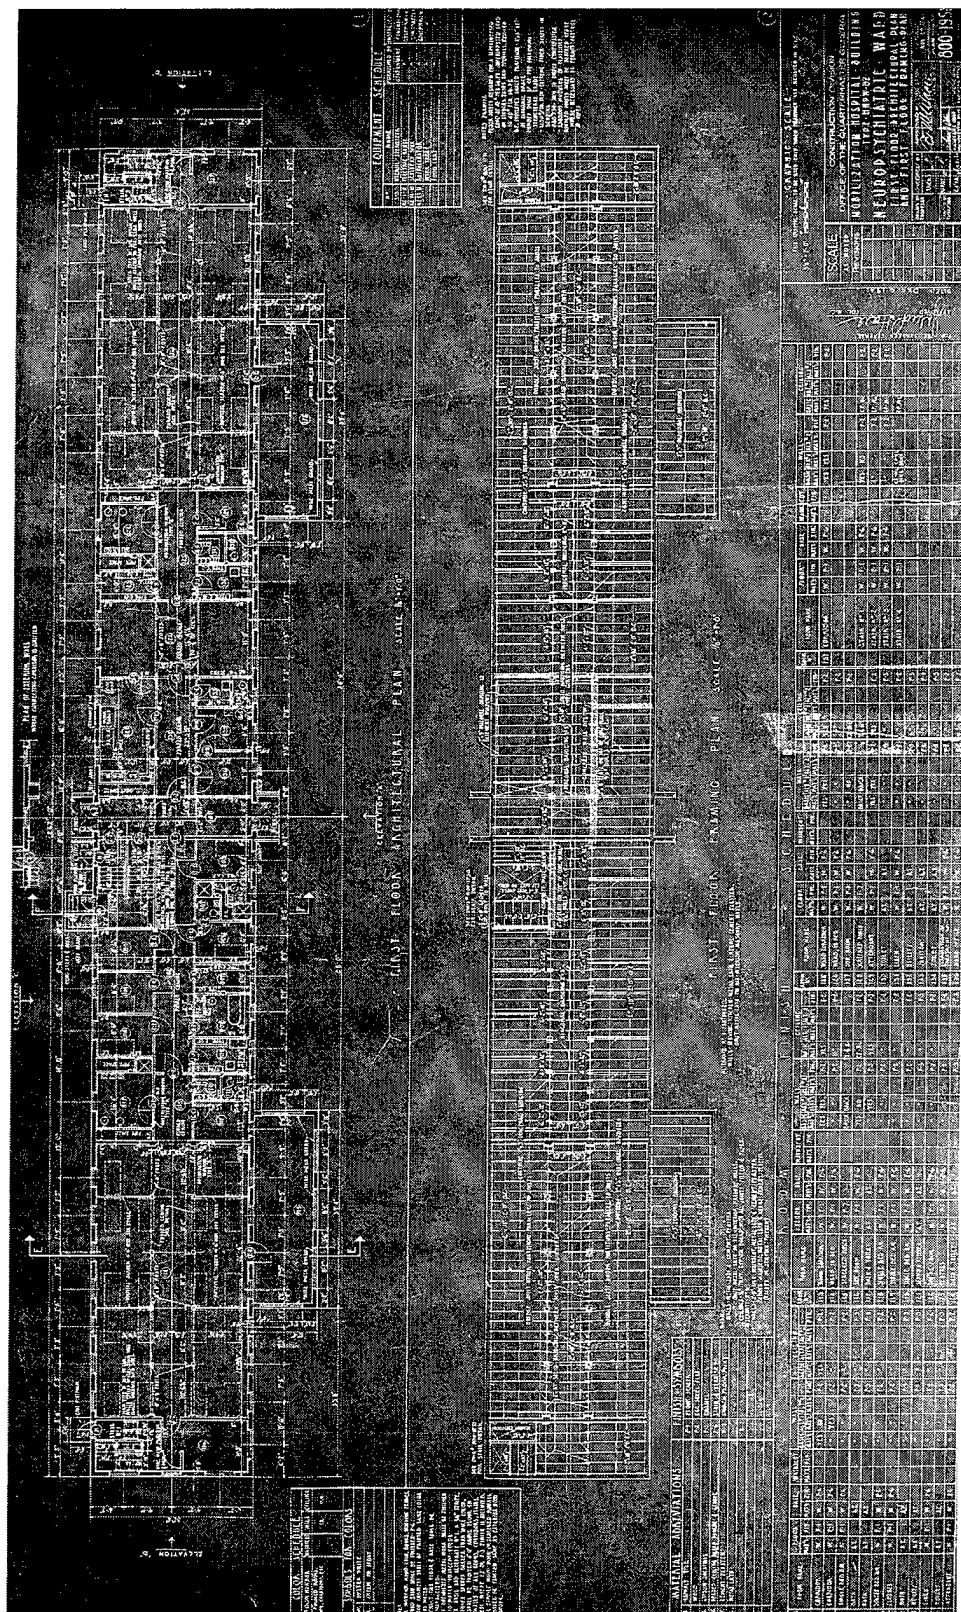
Figure V.73 5EP1778. First-floor architectural and framing plans for Building S6253, Neuropsychiatric Ward. 800 Series, Type HNPW-82, Plan 800-1958.

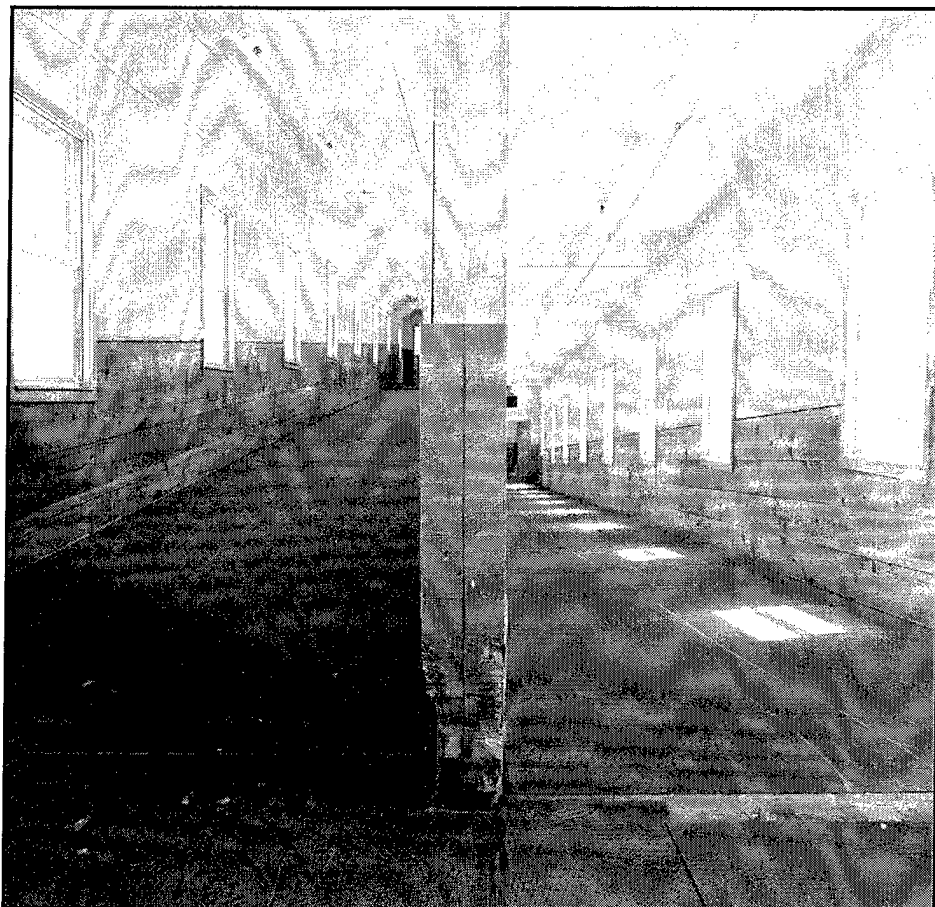
Figure V.86 5EP1778. Interior shot of corridor connecting Buildings S6252 and S6253, showing construction materials. 800 Series, Type H.C.WK.-C. Roll 5, Exposure 9.

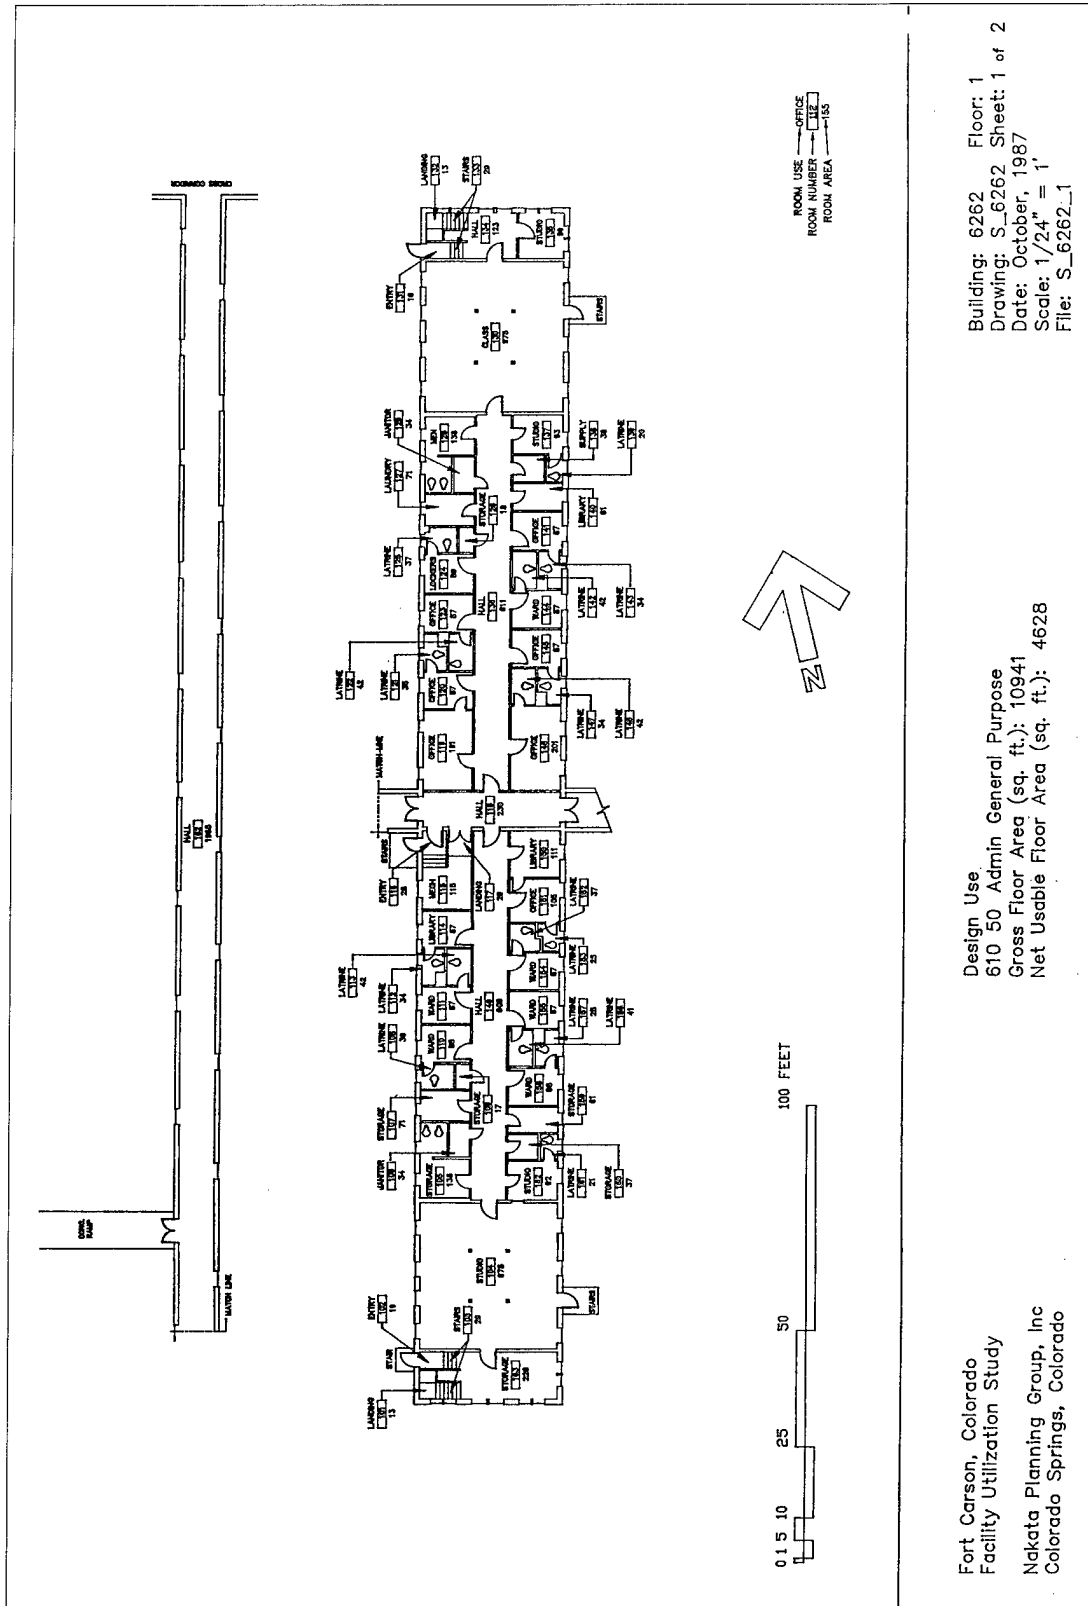
Figure V.89 5EP1778. First-floor plan for Building S6262, Special Ward, BUD Series.

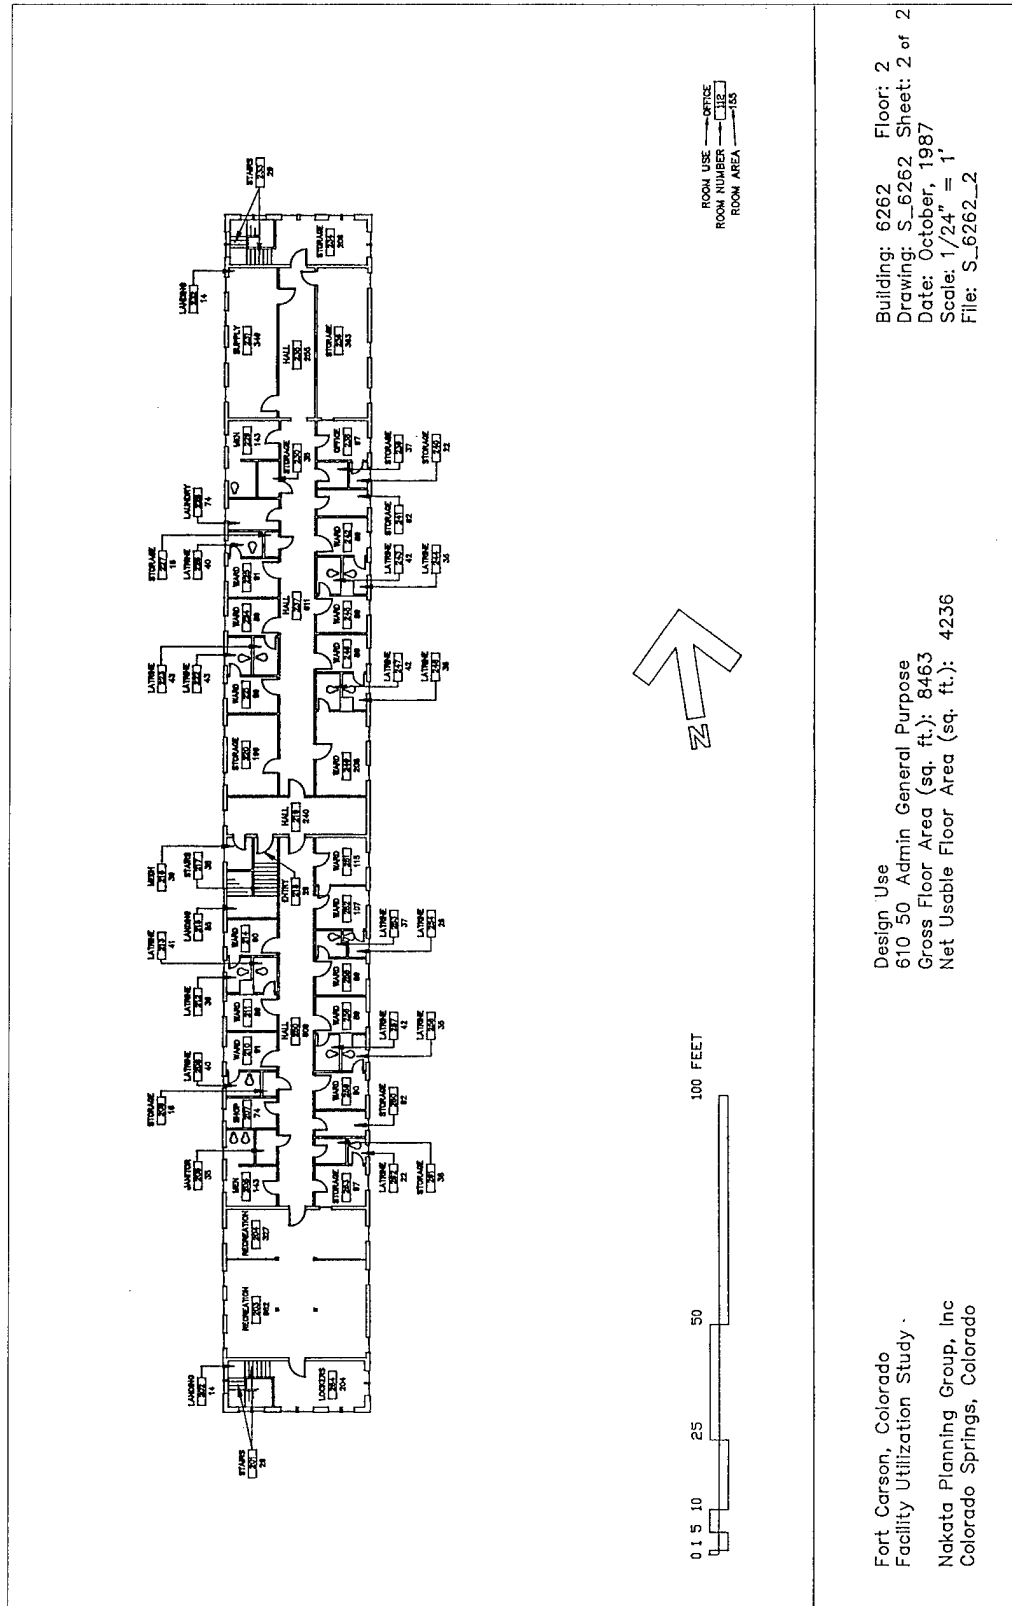
Figure V.90 5EP1778. Second-floor plan for Building S6262, Special Ward, BUD Series.

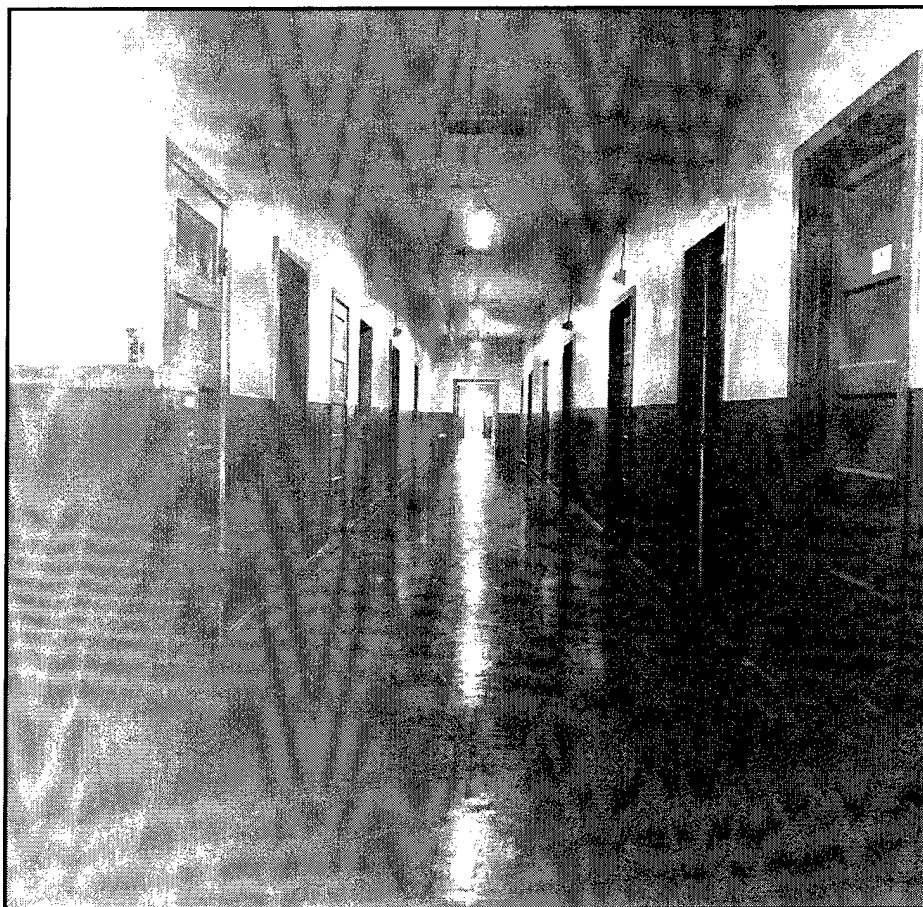
Figure V.97 5EP1778. Building S6262. Special Ward, 800 Series, Type HSPW-76. Interior view of second floor hallway, facing north. Roll 15C, Exposure 5.

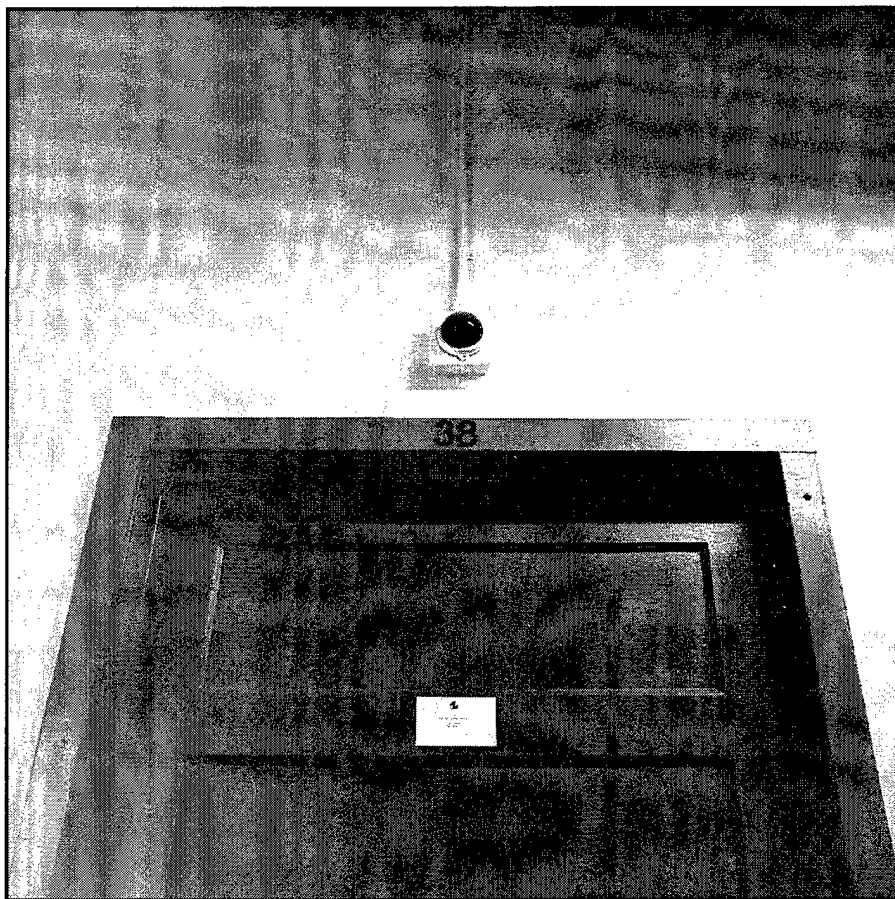
Figure V.98 5EP1778. Building S6262, Special Ward, 800 Series, Type HSPW-76. Interior shot of blue light above patient's door. Roll 15C, Exposure 2.

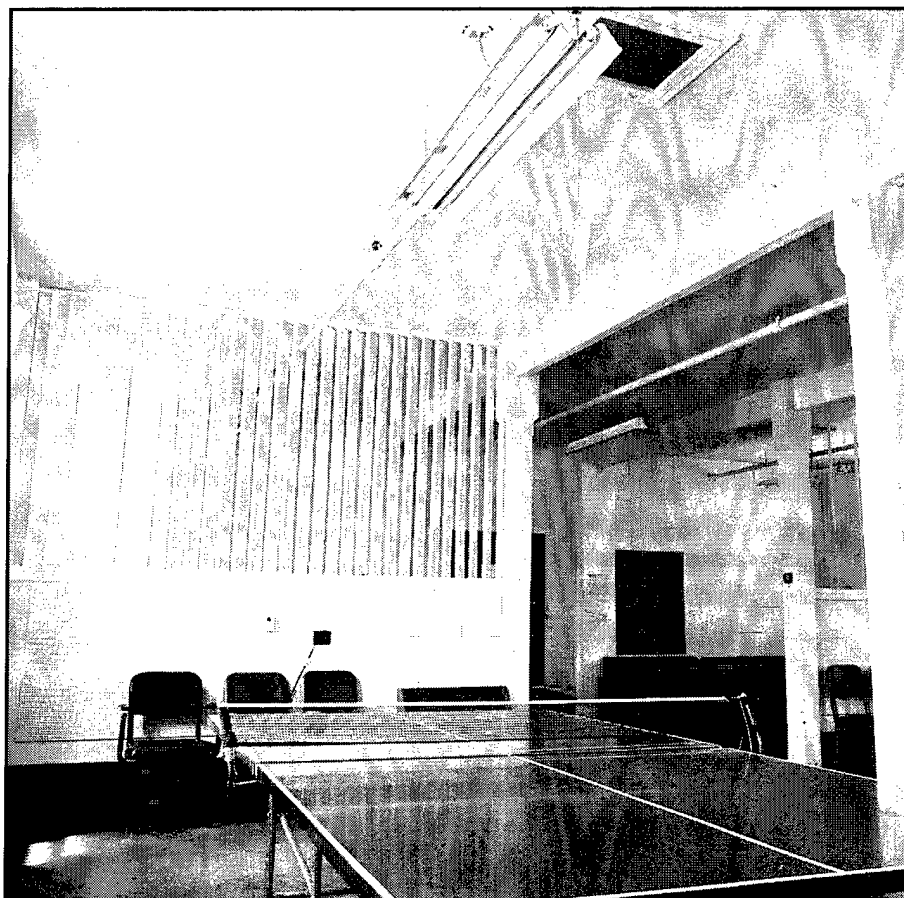
Figure V.99 5EP1778. Building S6262, Special Ward. 800 Series. Type HSPW-76. Interior shot of slotted wood divider in ward, from southwest corner of room. Roll 15C, Exposure 11.

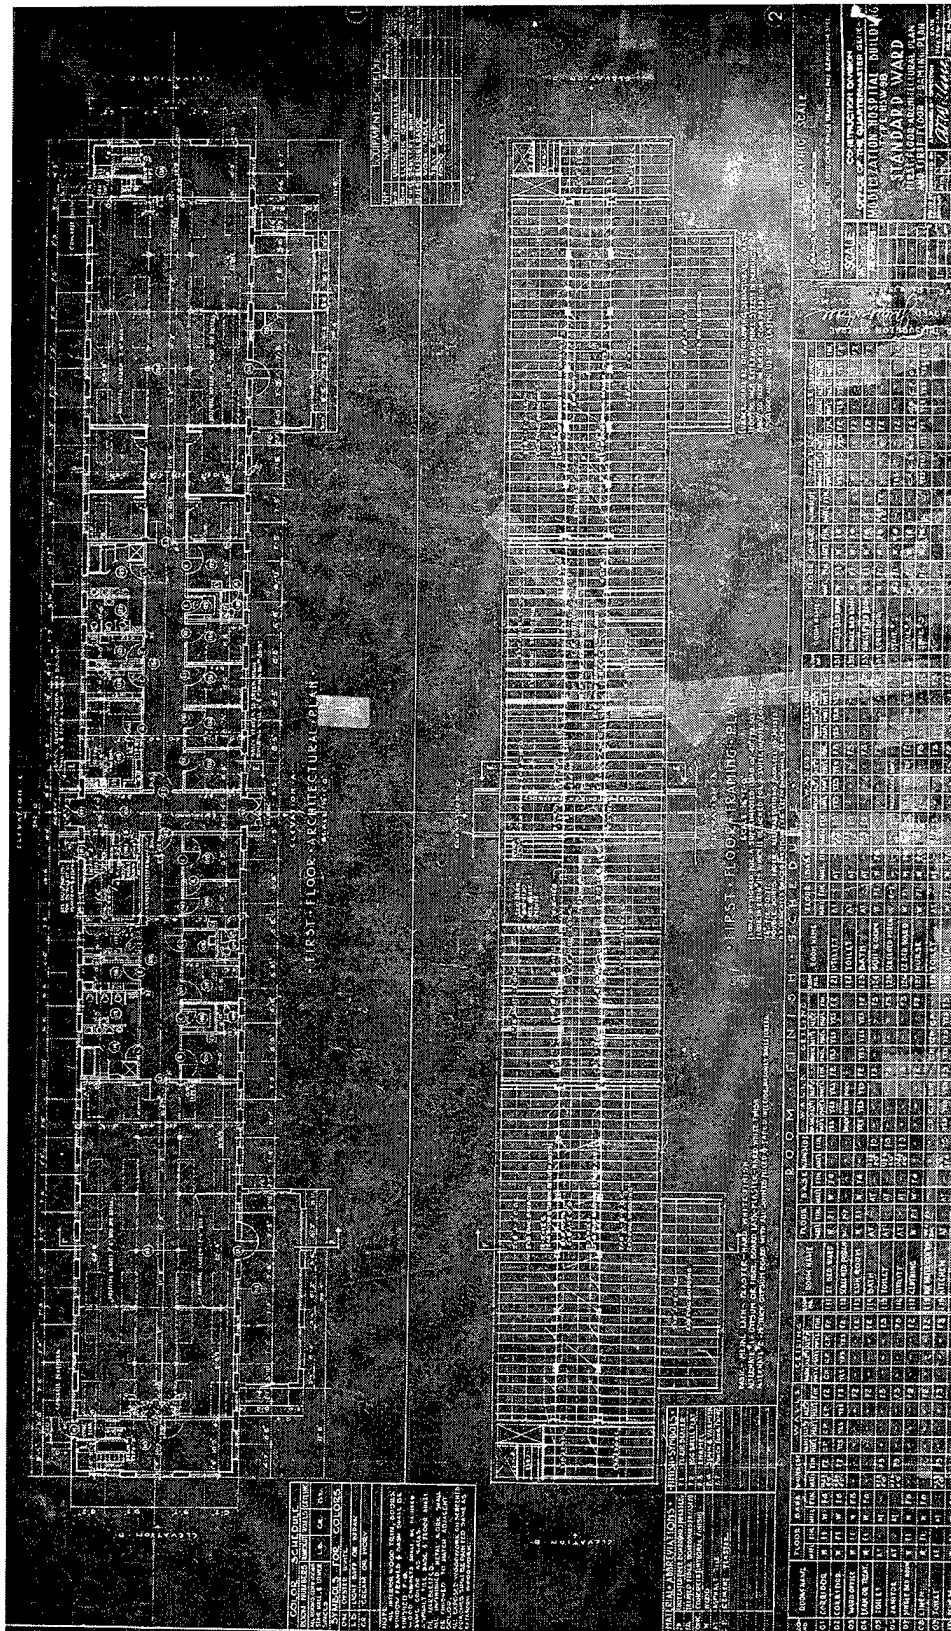
Figure V.106 5EPI778. First-floor architectural and framing plans for Building S6252, Standard Ward, 800 Series, Type HSW-98, Plan 800-1935.

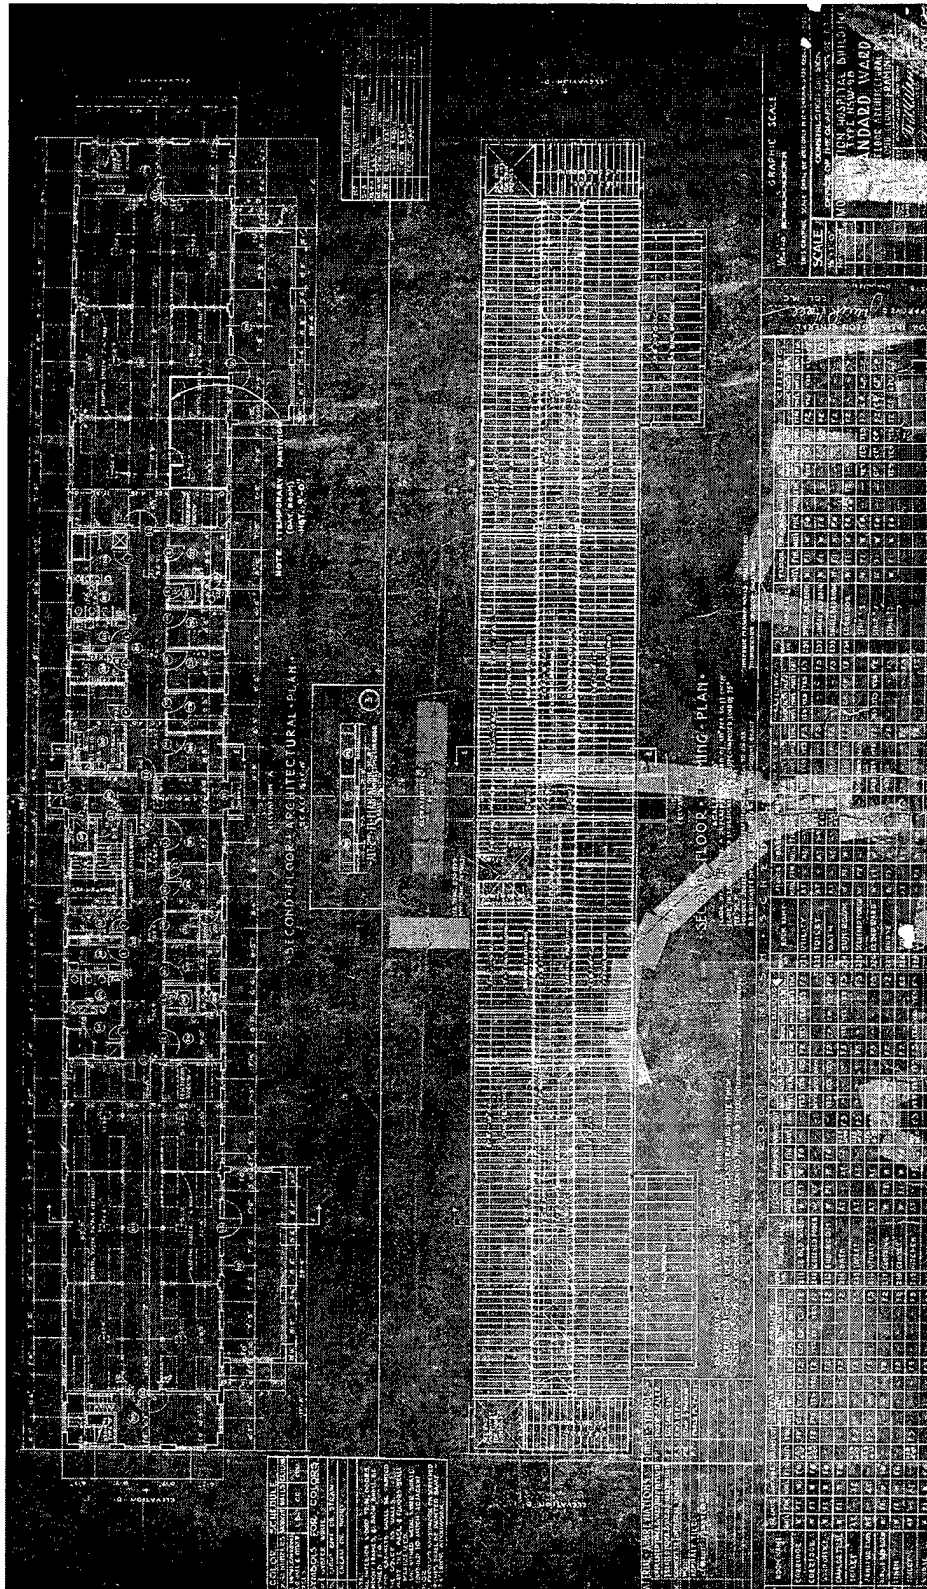
The floor system is wood-joist construction. Joists bear on interior, built-up longitudinal beams. The second floor beams transfer loads to the foundation piers via solid wood pillars. Floor joists are covered by diagonally laid, tongue-in-groove subflooring, and finish flooring. Interior partition walls are constructed of 2" x 4" wood studs. Floor joists are doubled under the interior walls. The roof is supported by wood-trussed rafters that bear on the interior wood beams and the perimeter walls.

Figure V.107 5EPI778. Second-floor architectural and framing plans for Building S6252, Standard Ward, 800 Series, Type HSW-98, Plan 800-1936.

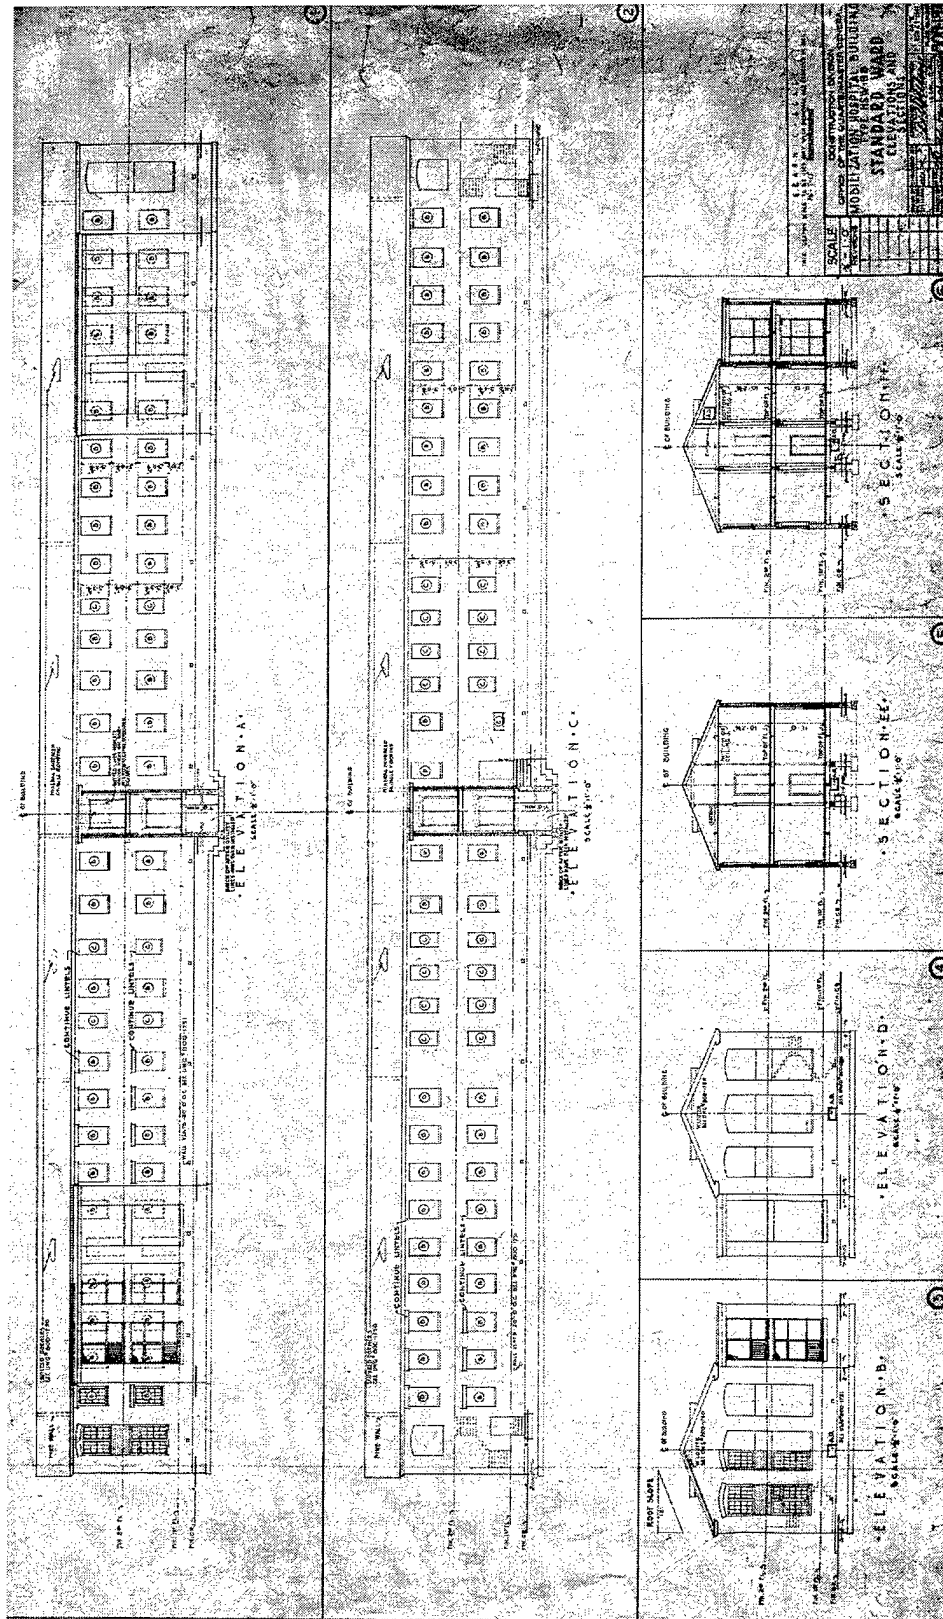
The side gable roof is moderately pitched and supported by wood trusses. The original mineral-surfaced shingle roofing has been replaced with three-tab asphalt shingles. Four louvered triangular eyebrow dormer vents are symmetrically arranged on each roof slope. Additional louvered vents sit under both gable peaks. The boxed eave overhangs 6" on the east and west sides. The gable ends have subtle cornice returns at the eave line. The cornice consists of a single 1" x 12" board topped with a strip of crown molding.

Figure V.108 SEP1778. Elevation and section plans for Building S6252, Standard Ward, 800 Series, Type HSW-98, Plan 800-1937.

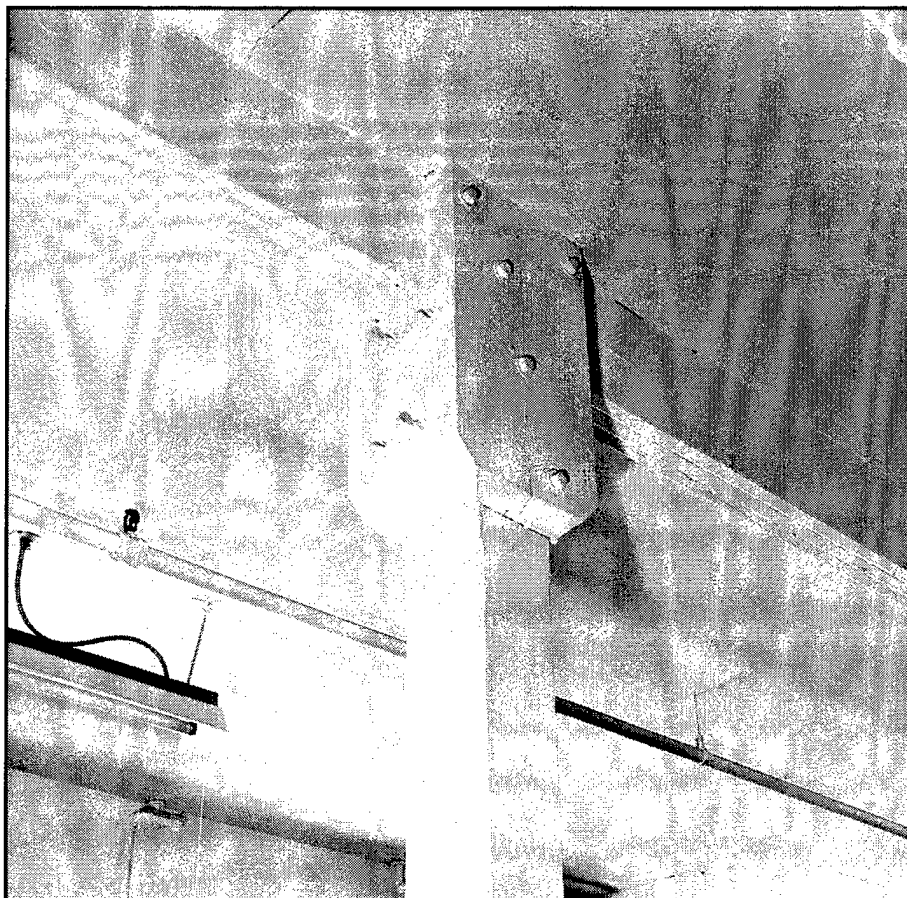
Figure V.114 5EP1778. Building S6252, Standard Ward, 800 Series, Type HSW-98. Interior view of stairwell and joist connection to wall. Roll 2, Exposure 8.

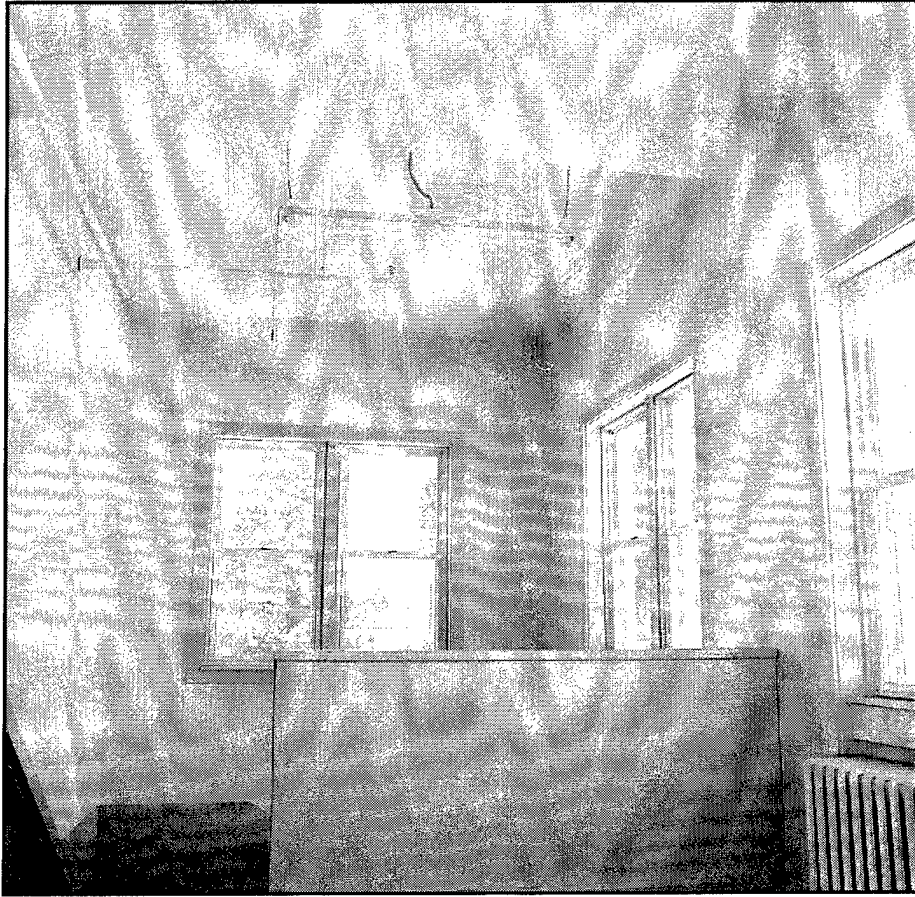
Figure V.115 5EP1778. Building S6252, Standard Ward, 800 Series, Type HSW-98. Interior view of ward. Roll 3, Exposure 8.

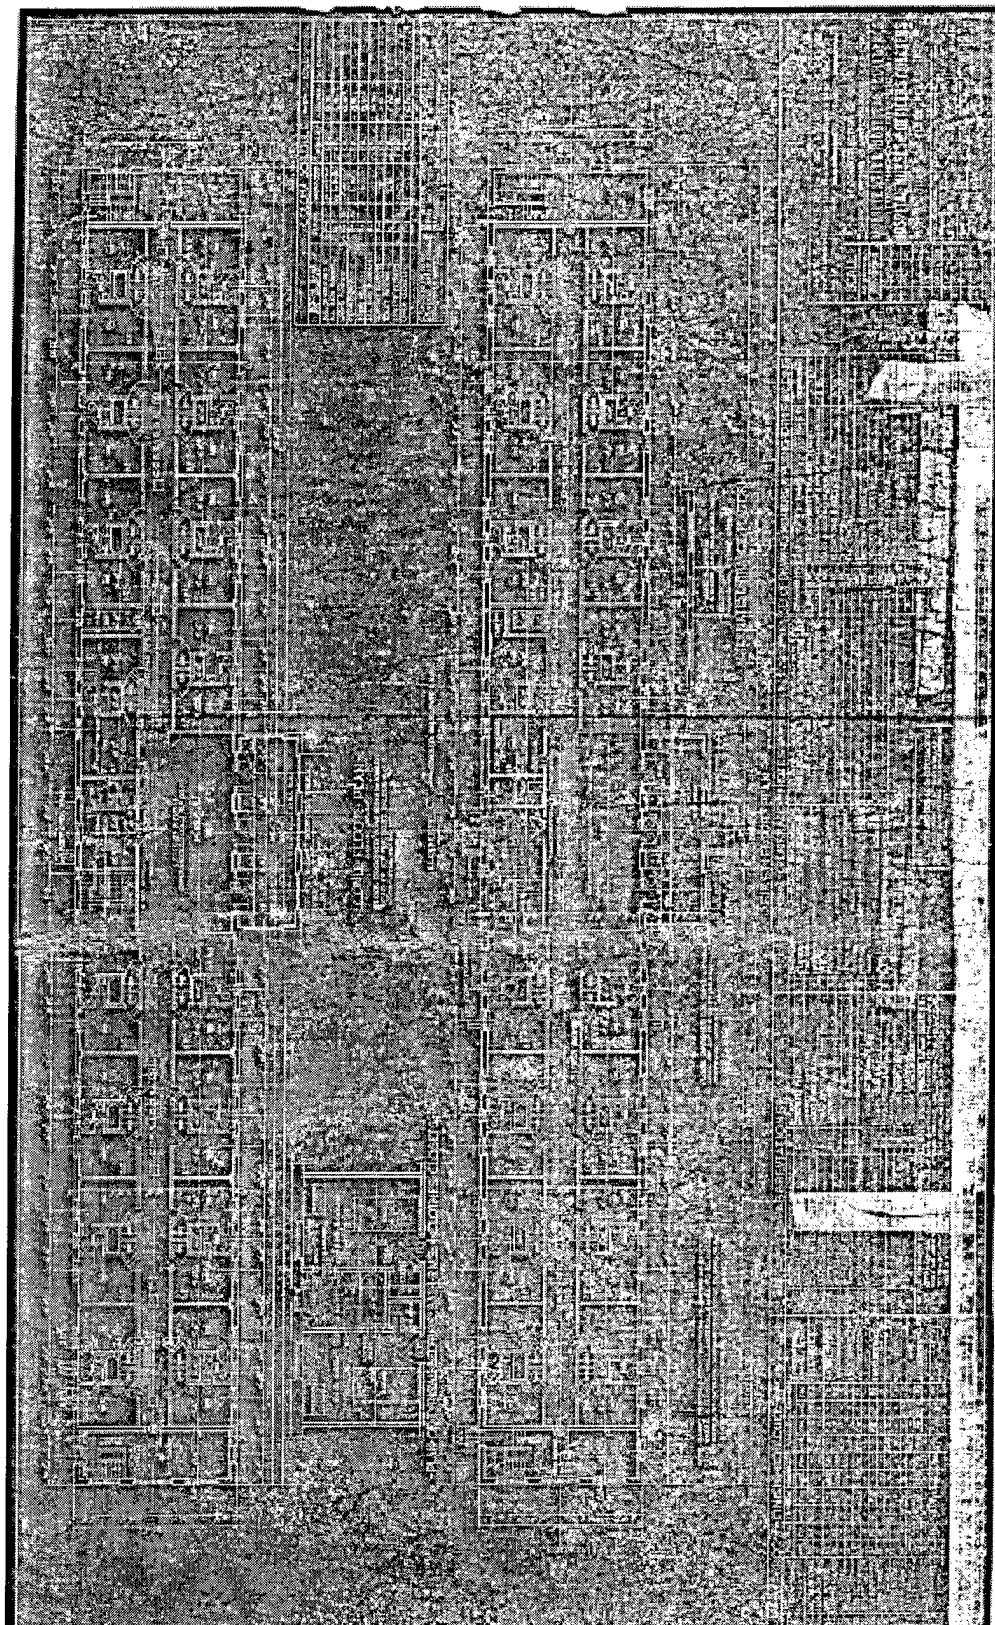
Figure V.119 SEP1778. First- and second-floor plans for Building S6222, Hospital Nurses or Officers Quarters, 800 Series, Type HNQ-63 or HOQ-63, Plan 800-1836.

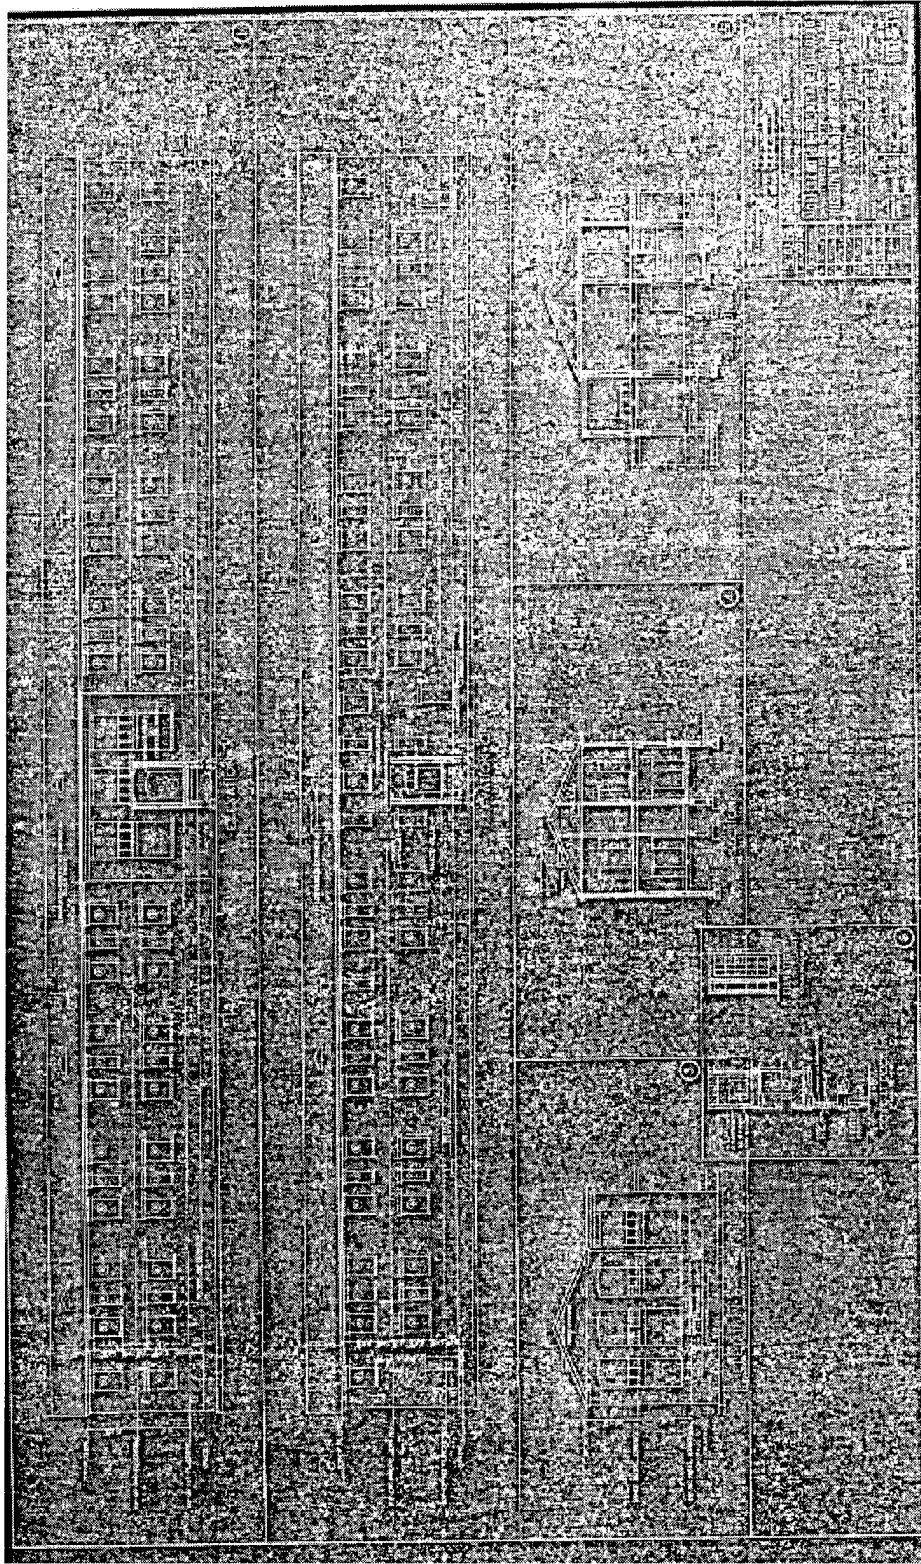
Figure V.120 5EP1778. Elevations and sections for Building S6222, Hospital Nurses or Officers Quarters, 800 Series, Type HNQ-63 or HOQ-63, Plan 800-1837.

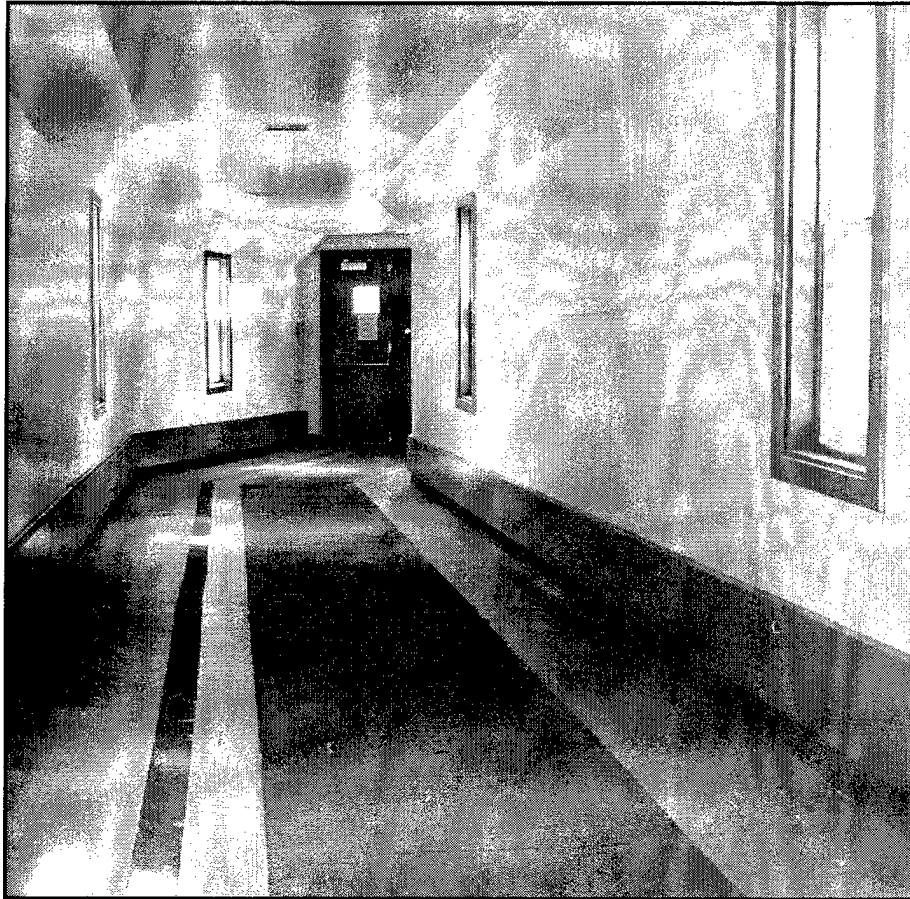
Heat is supplied through metal steam grills (radiators) supplied by the OHC's central heating plant. Steam pipes run underground and in the crawlspaces of the building and corridor. Air conditioning systems were installed in S6222 in 1979 and 1987. Sprinkler heads from the original fire sprinkler system are visible within the dropped-ceiling tiles.

Figure V.131 5EP1778. Building S6222, Hospital Nurses or Officers Quarters, 800 Series, Type HNQ-63 or HOQ-63. Interior view showing door, wall, and radiator pipe. Roll 2A, Exposure 10.

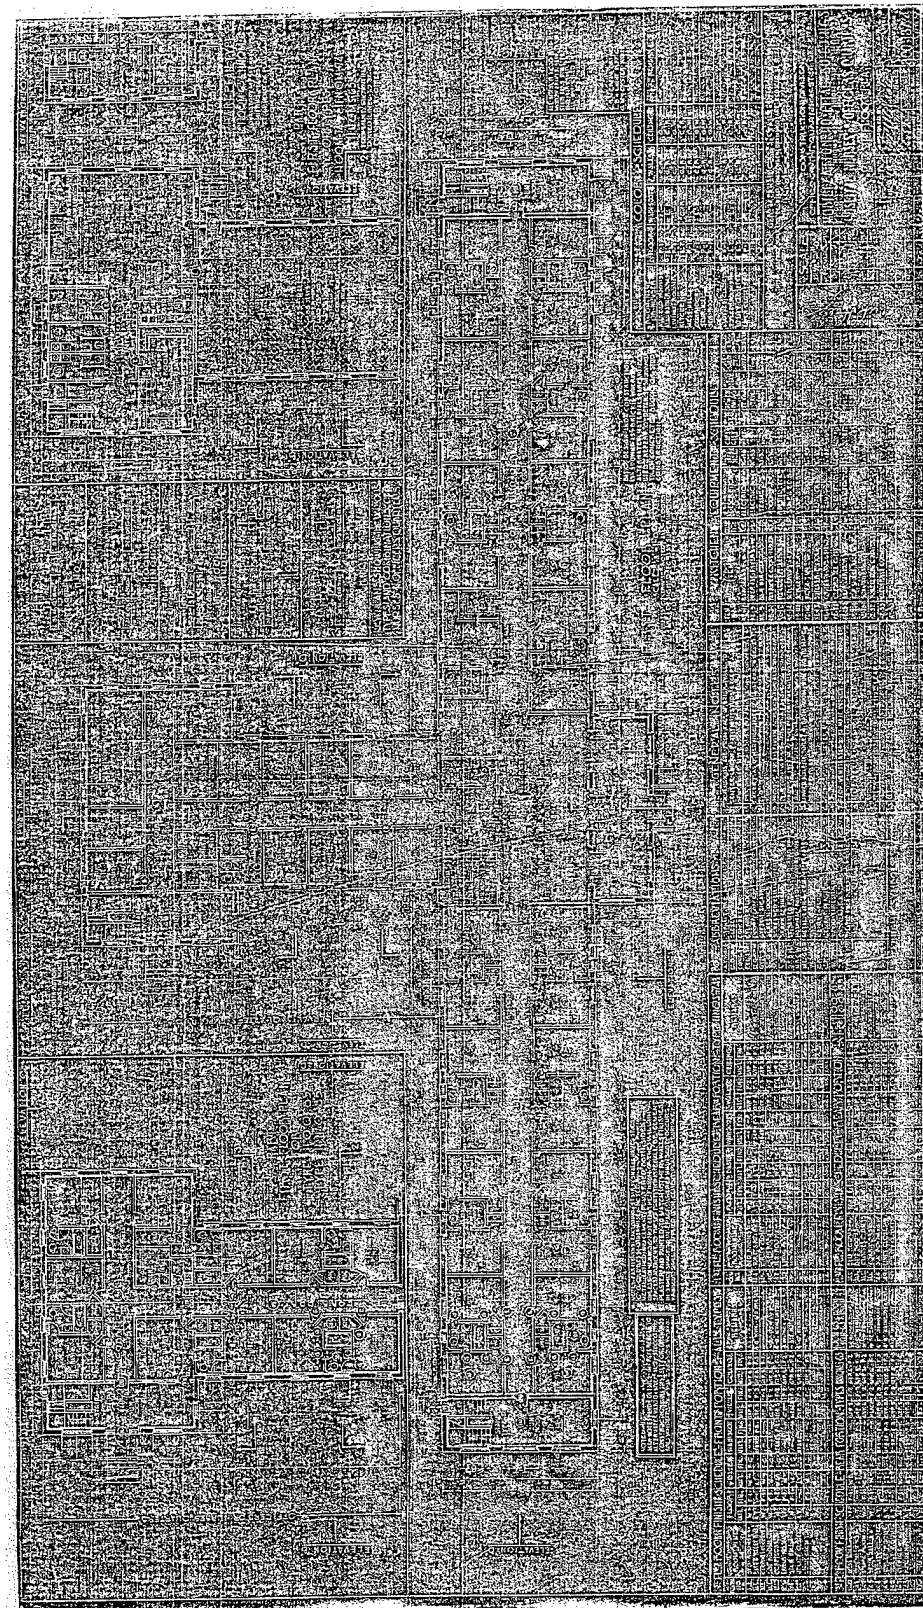
Figure V.132 5EP1778. First-floor plan for Buildings S6224 and S6228, Hospital Nurses or Officers Quarters, 800 Series, Types HOQM-63, HNQM-63, HNQMS-63, HOQM-74, HNQM-74, HNQS-74, HOQ-85, and HNQ-85, and HNQ-1844, Plan 800-1844.
